# Manhole Inspection Summary

Manhole # S03YY1017MH

Insp Date: **8/15/06 12:00 AM**

**Location** Address: **3316 LUDGATE RD**

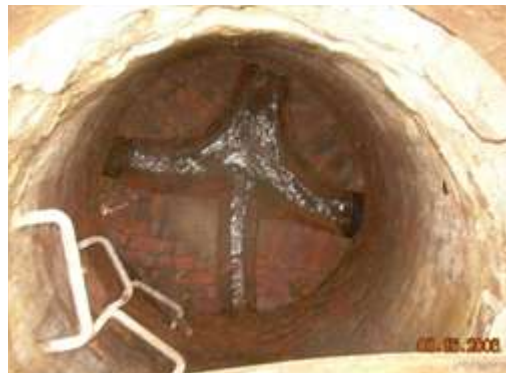
Top View

Comments **Top View picture indicates evidence of infiltration through the adjustment/chimney and the corbel wall.**

Infiltration: ☐ None ☒ **Joint** ☐ Cracks ☒ **Mortar** ☐ Roots ☐ Wall

Infiltration: ☐ None ☐ Joint ☐ Cracks ☒ **Mortar** ☐ Roots ☒ **Wall**

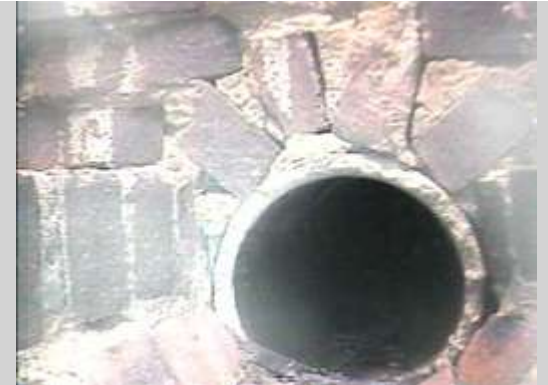
### 8 in. Circular Gravity Sewer Pipe Out @ 12 O'Clock

Infiltration: **Evidence** Pipe Seal Cond: **Unknown**

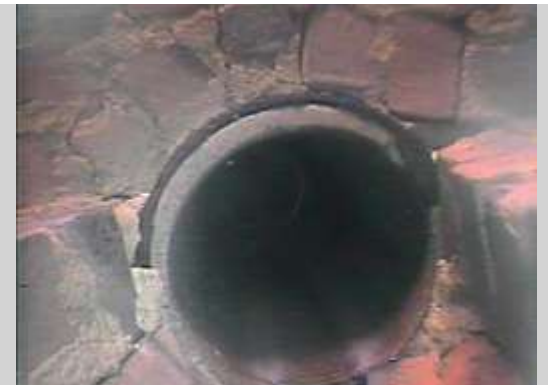
### 8 in. Circular Gravity Sewer Pipe In @ 3 O'Clock

Infiltration: **Evidence** Pipe Seal Cond: **Unknown**

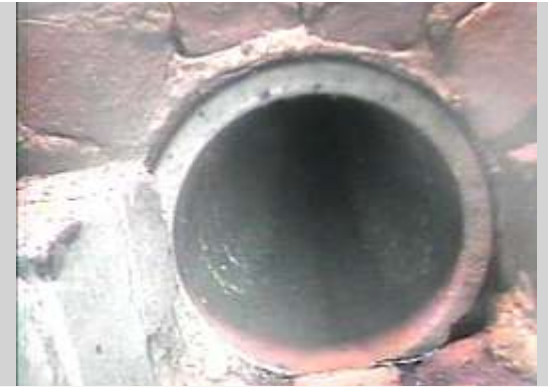
### 6 in. Circular Gravity Sewer

Infiltration: **Evidence**

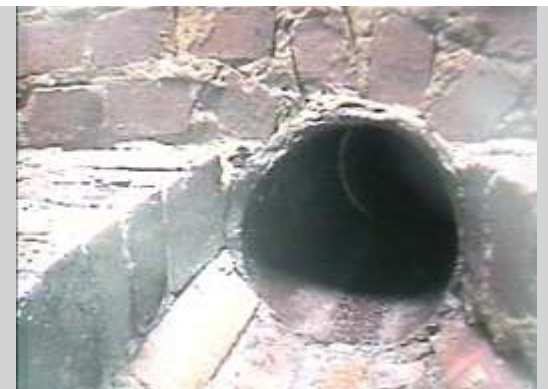
### 8 in. Circular Gravity Sewer

Infiltration: **None**
